# Inspection Report

## Sample Report

**Property Address:**  
1997 Inspection Street  
Largo FL 33773

**Superior Home Inspection Services**

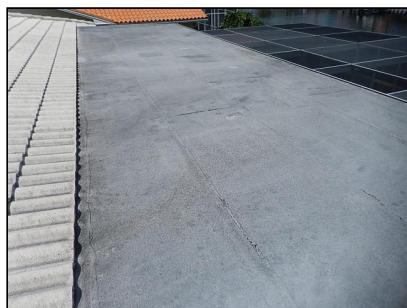
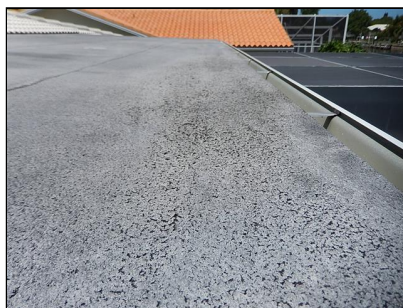
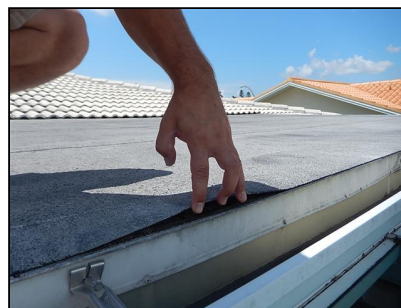
(1) The flat roof membrane covering at the rear of the home is nearing the end of its serviceable life. The covering is cracking at areas and loose at the roof edge. Sealing the covering with an approved coating may prolong the life and prevent leaks. Recommend consulting with a licensed roofing contractor to determine the need for replacement.

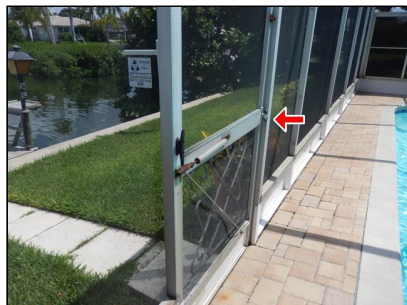
2.1 Item 1(Picture)

The rear entry door to the pool enclosure does not latch when closed. This is a safety issue at pool enclosures.

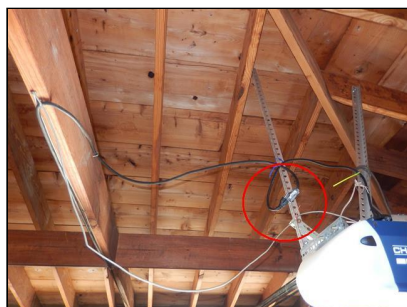
3.5 Item 1(Picture)

The automatic garage door opener is using a non-grounded extension cord for permanent wiring and should be plugged in to its own outlet. Recommend a licensed electrician correct as needed.

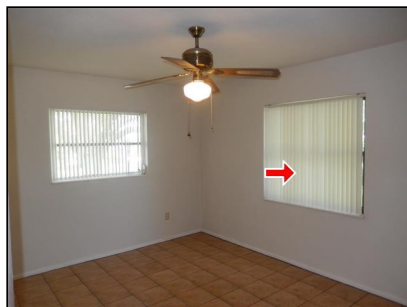
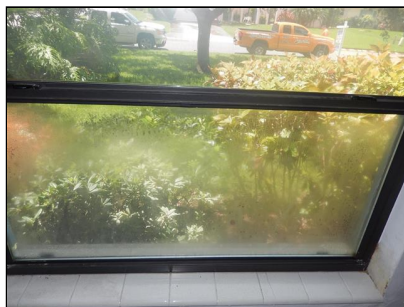
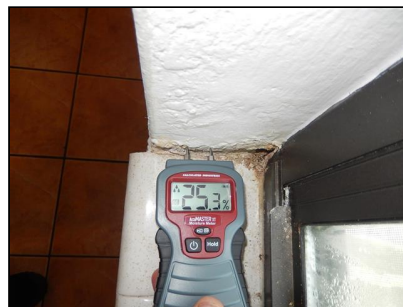
Window(s) in the front bedroom are cloudy indicating the seals are failing and moisture intrusion is occurring between the glass panes. Recommend repair or replace as needed. The walls were deteriorated at the frame and tested wet indicating active water intrusion is occurring. Recommend repair.

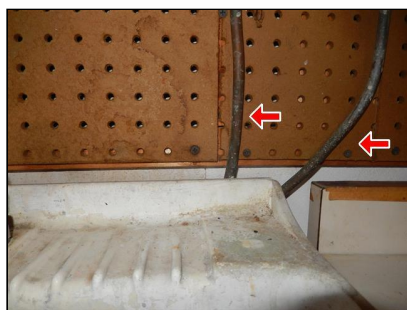
6.1 Item 1(Picture)

(1) The supply lines for the utility sink do not have individual shut offs. Recommend a licensed plumber install shut offs. The hot control knob on the sink faucet was seized or not functional with normal force.

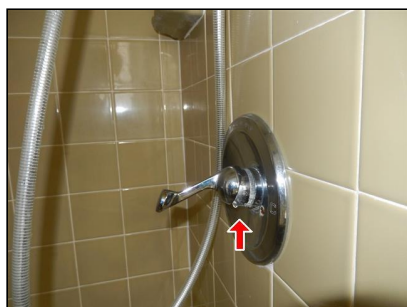
6.1 Item 2(Picture)

(2) The shower control leaks from behind the handle when on in the master bathroom. Repair or replacement is recommended.

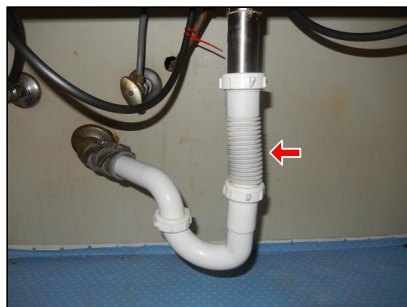
6.2 Item 1(Picture)

(1) The waste line for the guest bathroom sink has an improper connection. Flexible piping is being used that should be solid, smooth walled PVC. This is not considered up to today's standards and should be corrected to prevent clogs or drainage issues. Recommend repair by a licensed plumber.

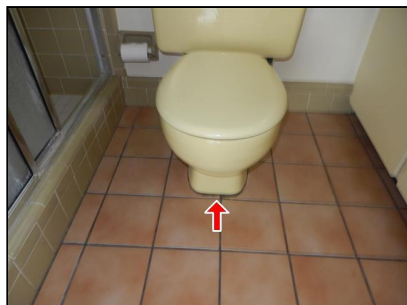
6.2 Item 2(Picture)

(2) The toilet in the master bathroom has staining at the base and signs of high moisture. This is typically an indication the wax ring seal is failing. Recommend resetting the toilet on a new wax seal and caulking the base.

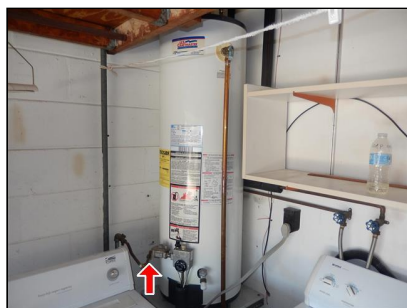
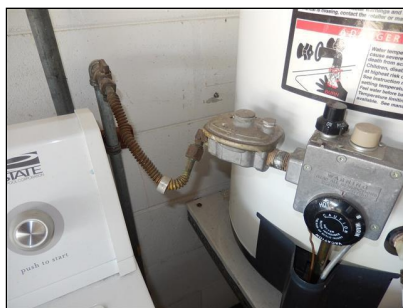
The water heater needs a sediment trap installed at the gas line connection. The water heater is considered aged or nearing the end of its life expectancy of 15-20 years. The inspected unit is 22 years old, however there were no visible leaks and the unit provided hot water at the time of the inspection. Replace as needed or desired.

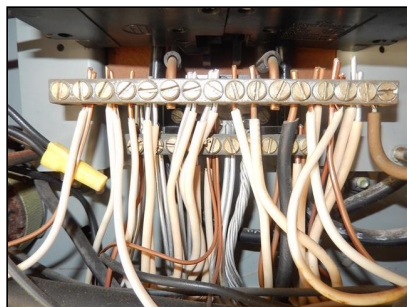
7.3 Item 1(Picture)

Aluminum wire is installed on 120v branch electrical circuits (15A and 20A) in the subject house. These single strand, branch circuit aluminum wires were used widely in houses during the mid 1960s to the mid 1970s. According to the U.S. Consumer Product Safety Commission, problems due to expansion can cause overheating at connections between the wire and devices (switches and outlets) or at splices, which has resulted in fires. Insurance companies typically require remediation of aluminum wiring prior to issuing a homeowners policy. A qualified licensed electrician should remedy as necessary.

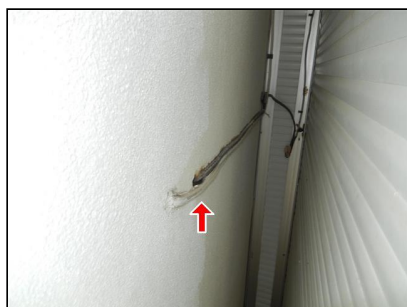
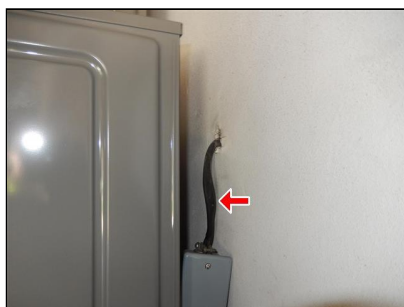
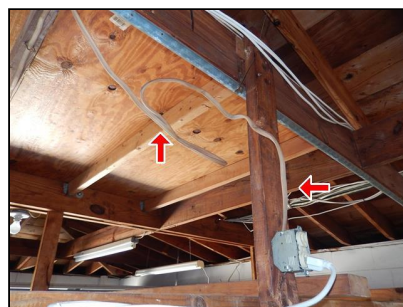
(1) Exposed wiring at the rear patio, in the garage, and under the kitchen sink should be properly concealed in conduit for safety and to prevent damage. A licensed electrician should perform repairs that involve wiring.

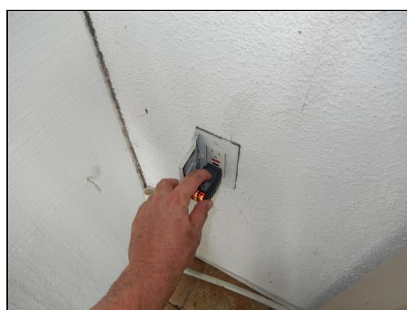
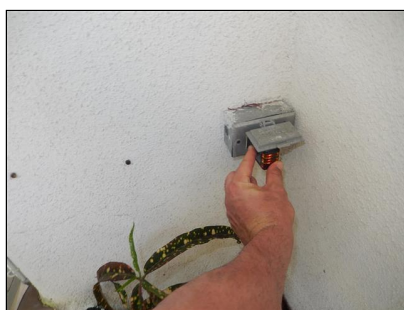
(1) The exterior GFCI outlets at the rear patio and right of the main entry wouldn't trip or respond to testing. Replacement of the outlet is recommended for safety.

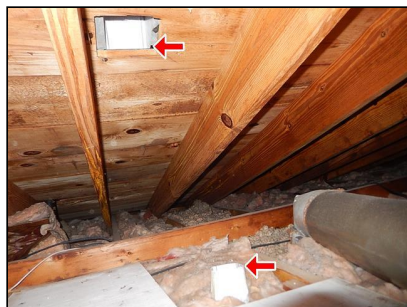
9.1 Item 1(Picture)

The guest bathroom exhaust fan is not properly connected to the roof vent in the attic space.

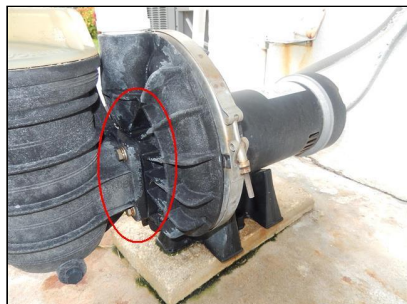
12.3 Item 1(Picture)

Leaks or water seepage was noted at the main seal of the pool pump.

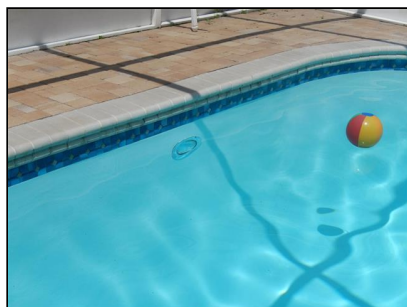
12.5 Item 1(Picture)

The pool light was out.

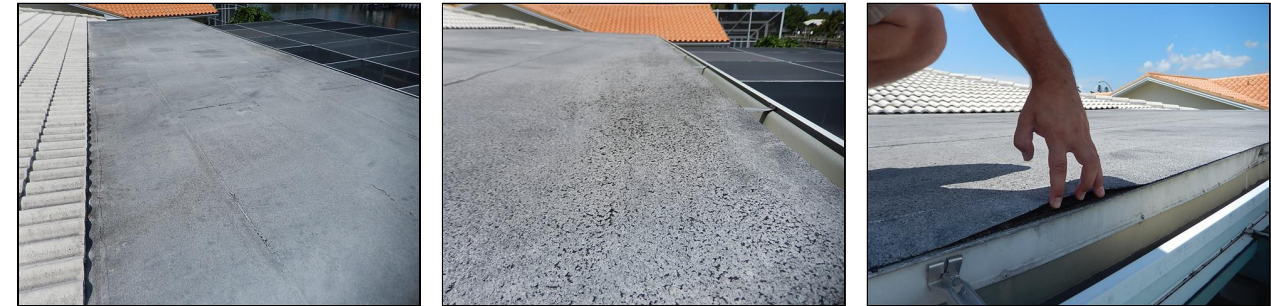
1.0 (1) The flat roof membrane covering at the rear of the home is nearing the end of its serviceable life. The covering is cracking at areas and loose at the roof edge. Sealing the covering with an approved coating may prolong the life and prevent leaks. Recommend consulting with a licensed roofing contractor to determine the need for replacement.

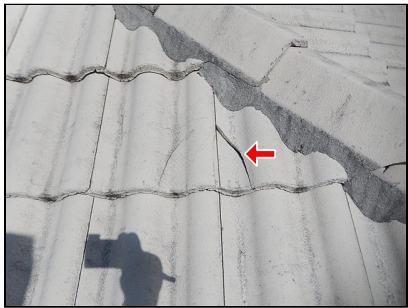
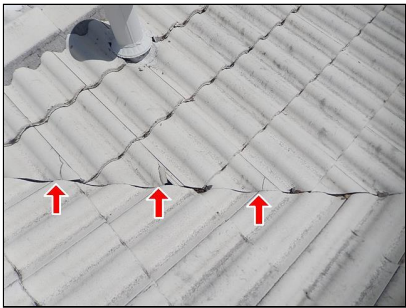
1.0 (2) Minor cracks were observed on tiles. Repair or replace as needed.

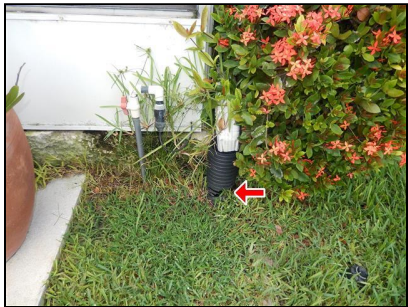
1.3 Item 1(Picture)

1.3 Damaged drain parts were noted at the rear downspouts.

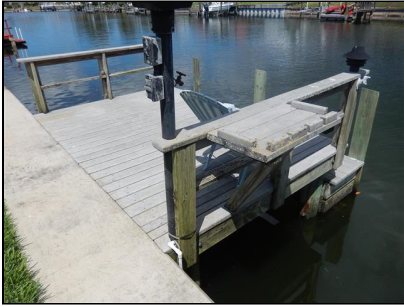
2.3 Item 1(Picture)

2.3 (1) The railings at the deck are loose and show signs of deterioration at the fasteners. Recommend repair or replacement.

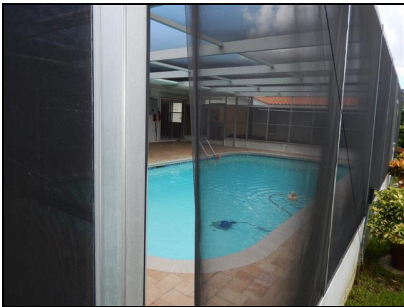
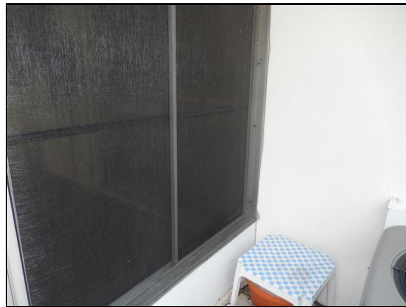
2.3 (2) Damaged or loose screens were observed at one or more areas of the rear enclosure. Repair or replace as needed.

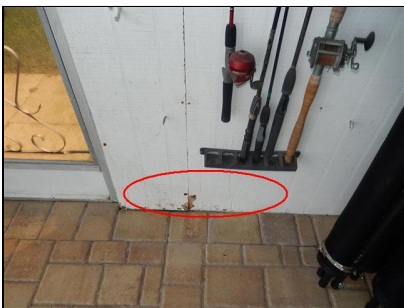
2.3 Item 4(Picture)

2.3 (3) Rooted interior wall panels in the rear enclosure were noted. Recommend removal or replacement as further deterioration will occur.

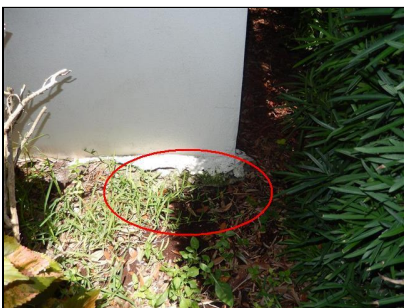
2.4 Item 1(Picture)

2.4 Soil erosion is occurring at the front of the home right corner. Recommend adding fill dirt or landscaping to prevent further erosion. Installing gutters or improving drainage (if applicable) may help prevent future erosion.

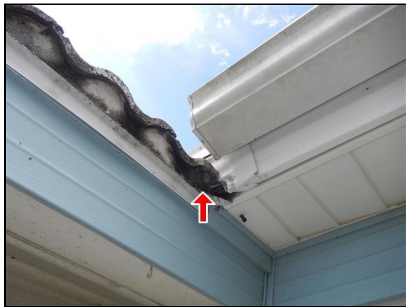
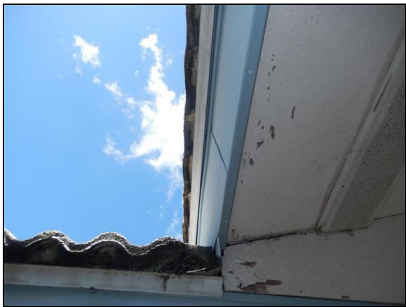
2.5 There was evidence of wood deterioration or rot of the fascia board(s) at one or more areas at the exterior of the home at the right side. Recommend repair or replacement to prevent further deterioration. Failing or peeling paint was observed at areas on the fascia and soffit boards.

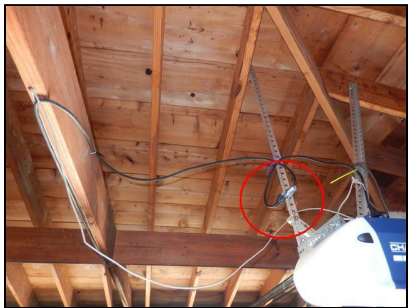
3.5 Item 1(Picture)

- 3.3 The weather stripping at the bottom of the garage door needs improvement or replaced to allow the door to properly seal to the ground and prevent water from entering the garage space.
- 3.4 The door from the garage to inside the home does not appear to be a fire rated door. This means that should a fire occur in the garage, the occupant door does not provide protection until fire fighters arrive. This door should be replaced with a fire rated door.
- 3.5 The automatic garage door opener is using a non-grounded extension cord for permanent wiring and should be plugged in to its own outlet. Recommend a licensed electrician correct as needed.

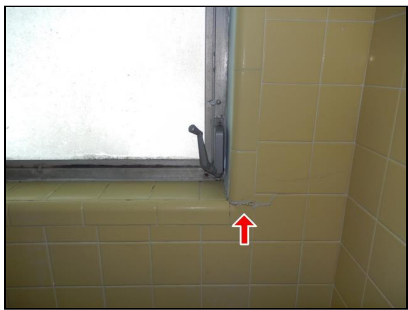
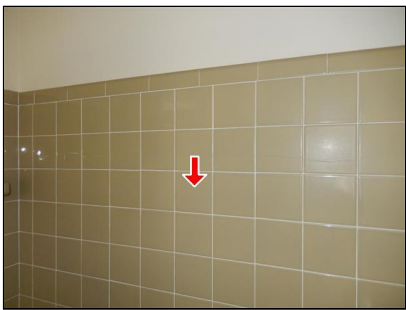
4.1 Wall tiles in both bathroom showers are cracked at various areas. Water intrusion may occur behind the walls.

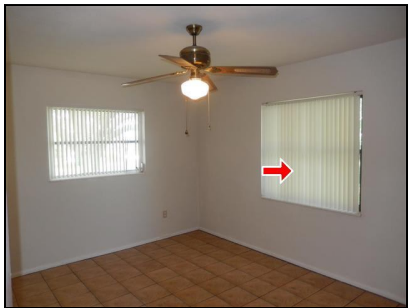
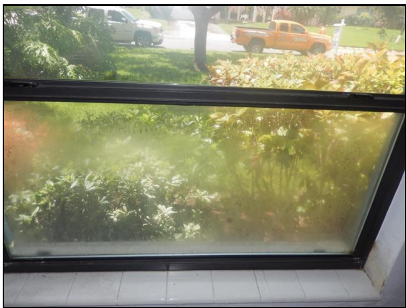
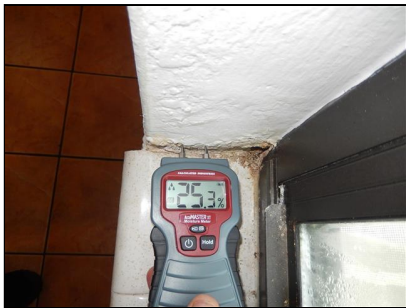
4.5 Window(s) in the front bedroom are cloudy indicating the seals are failing and moisture intrusion is occurring between the glass panes. Recommend repair or replace as needed. The walls were deteriorated at the frame and tested wet indicating active water intrusion is occurring. Recommend repair.

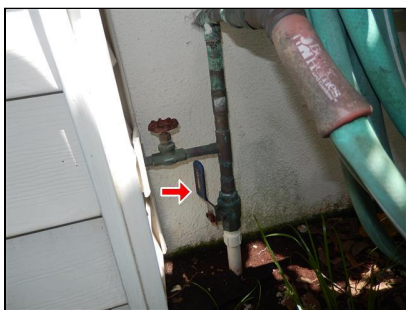
6.0 Item 1(Picture)

**6.0** The main water shut off to the home is the lever located at the front exterior wall right of the main entry.

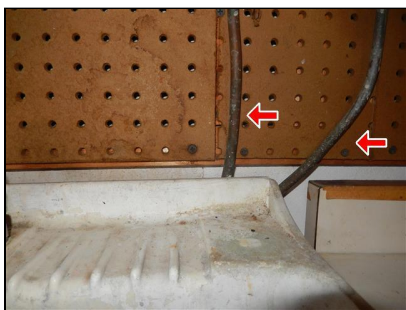
6.1 Item 1(Picture)

**6.1 (1)** The supply lines for the utility sink do not have individual shut offs. Recommend a licensed plumber install shut offs. The hot control knob on the sink faucet was seized or not functional with normal force.

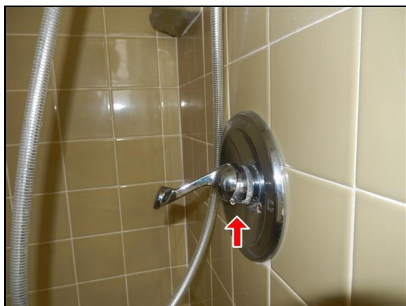
6.1 Item 2(Picture)

**6.1 (2)** The shower control leaks from behind the handle when on in the master bathroom. Repair or replacement is recommended.

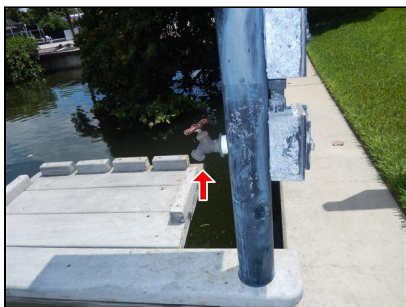
6.1 Item 3(Picture)

**6.1 (3)** The water supply at the rear deck was not functional. Consult with the current owner for location of an additional shut off.

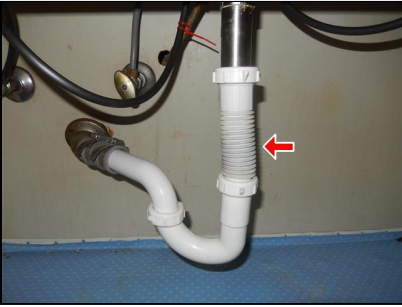
6.2 Item 1(Picture)

**6.2** (1) The waste line for the guest bathroom sink has an improper connection. Flexible piping is being used that should be solid, smooth walled PVC. This is not considered up to today's standards and should be corrected to prevent clogs or drainage issues. Recommend repair by a licensed plumber.

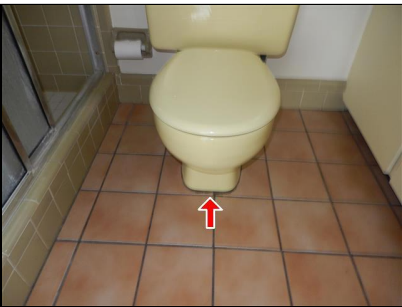
6.2 Item 2(Picture)

**6.2** (2) The toilet in the master bathroom has staining at the base and signs of high moisture. This is typically an indication the wax ring seal is failing. Recommend resetting the toilet on a new wax seal and caulking the base.

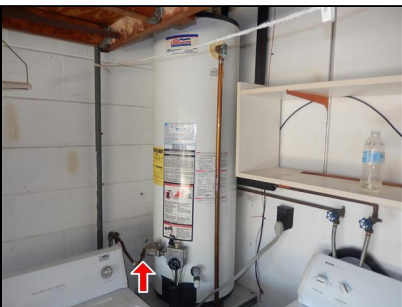
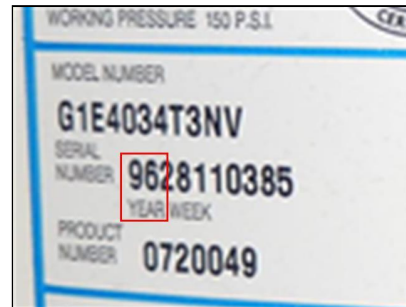
**6.3** The water heater needs a sediment trap installed at the gas line connection. The water heater is considered aged or nearing the end of its life expectancy of 15-20 years. The inspected unit is 22 years old, however there were no visible leaks and the unit provided hot water at the time of the inspection. Replace as needed or desired.

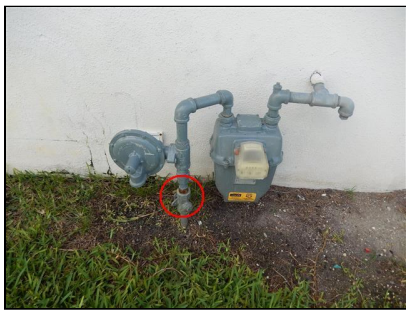
6.4 Item 1(Picture)

## 6.4 The main fuel shut off is at the gas meter outside.

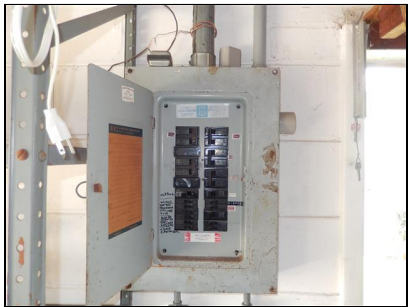
7.0 Item 1(Picture)

7.0 The main electric panel is located in the garage. Missing cover screws need replaced.

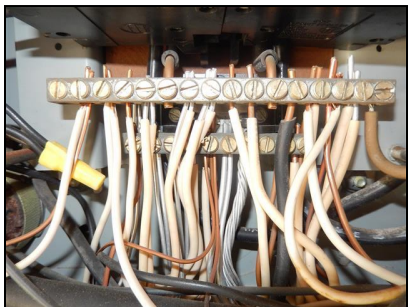
7.3 Item 1(Picture)

7.3 Aluminum wire is installed on 120v branch electrical circuits (15A and 20A) in the subject house. These single strand, branch circuit aluminum wires were used widely in houses during the mid 1960s to the mid 1970s. According to the U.S. Consumer Product Safety Commission, problems due to expansion can cause overheating at connections between the wire and devices (switches and outlets) or at splices, which has resulted in fires. Insurance companies typically require remediation of aluminum wiring prior to issuing a homeowners policy. A qualified licensed electrician should remedy as necessary.

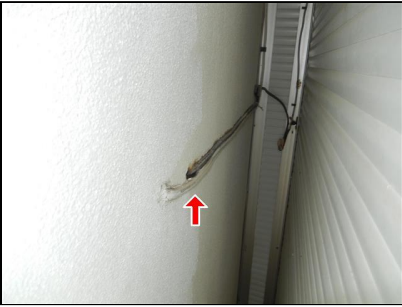
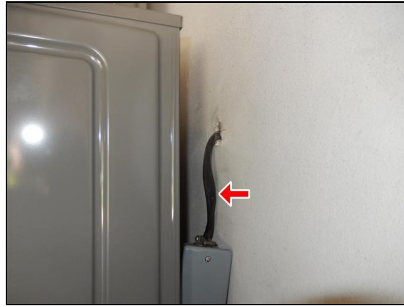
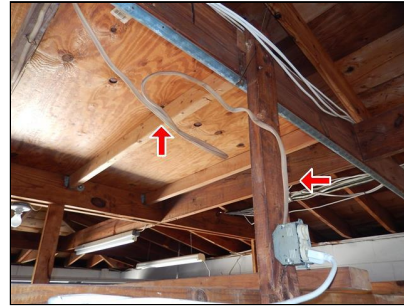
**7.4 (1)** Exposed wiring at the rear patio, in the garage, and under the kitchen sink should be properly concealed in conduit for safety and to prevent damage. A licensed electrician should perform repairs that involve wiring.

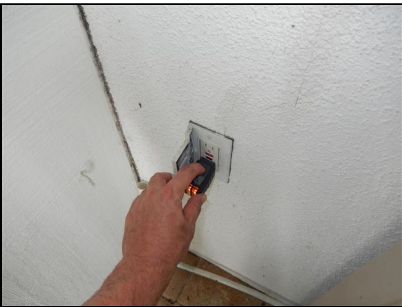
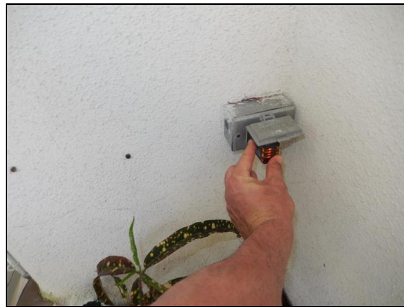
**7.6 (1)** The exterior GFCI outlets at the rear patio and right of the main entry wouldn't trip or respond to testing. Replacement of the outlet is recommended for safety.

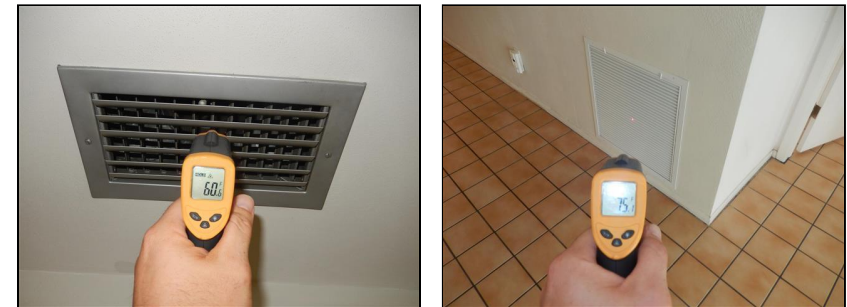
8.0 The ambient air test was performed by using thermometers on the air conditioning system to determine if the difference in temperatures of the supply and return air are between 14 degrees and 22 degrees which indicates that the unit is cooling as intended. The supply air temperature on your system read 60 degrees, and the return air temperature was 75 degrees. This indicates that the unit was performing properly at the time of inspection. Recommend changing the filter(s) upon moving in to the home and routine annual maintenance including coil cleaning by a licensed HVAC contractor to ensure proper function and longevity of the system.

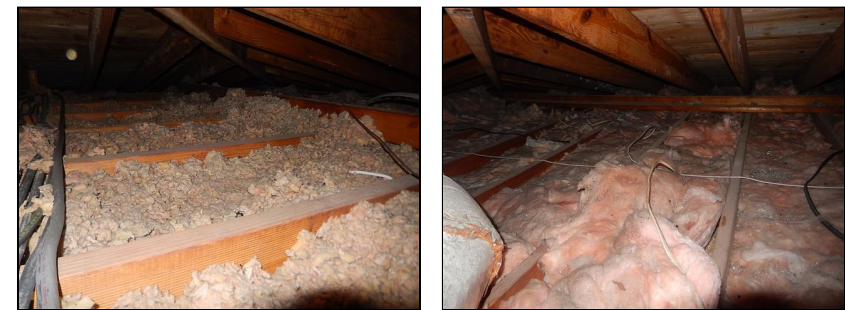
9.0 Insulation is old, has settled, and less than 6 inches in thickness remains in the attic. Heat/AC loss can occur more on this home than one that is properly insulated and the homes efficiency can be lowered without proper insulation in the attic space. Recommend having an energy audit performed by the local power company and add insulation as needed.

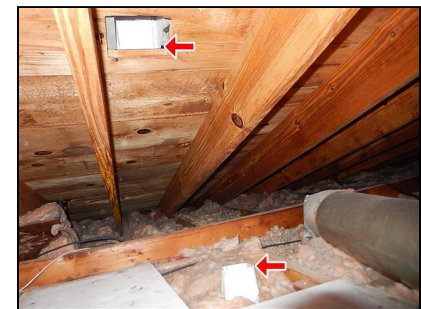
9.1 Item 1(Picture)

9.1 The guest bathroom exhaust fan is not properly connected to the roof vent in the attic space.

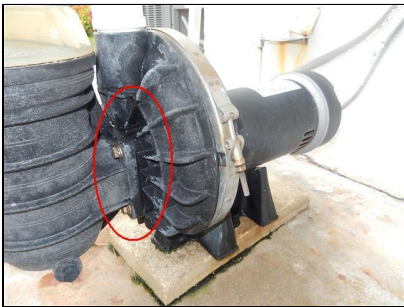
12.3 Item 1(Picture)

12.3 Leaks or water seepage was noted at the main seal of the pool pump.

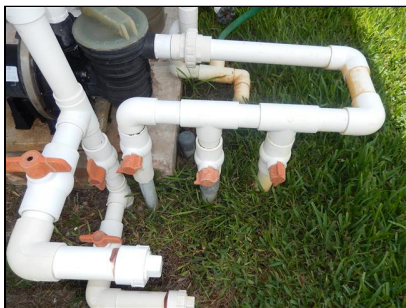
12.4 Item 1(Picture)

12.4 (1) Some knobs for the pool plumbing are damaged.

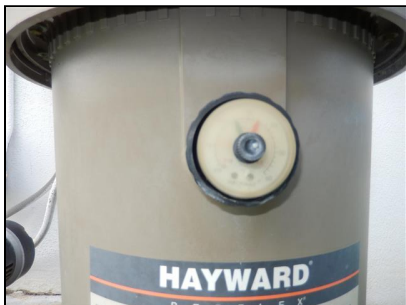
12.4 Item 2(Picture)

12.4 (2) The pressure gauge on the filter canister was damaged or not functional.

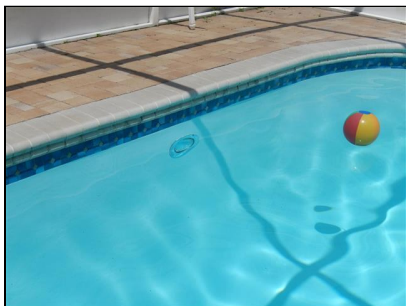
12.5 Item 1(Picture)

12.5 The pool light was out.
